RESEARCH MEMORANDUM

INFLUENCE OF BORIC OXIDE DEPOSITION ON TURBOJET-
ENGINE OPERATION

By James W. Useller, Richard R. Burley, and
Wallace W. Velie

Lewis Flight Propulsion Laboratory
Cleveland, Ohio

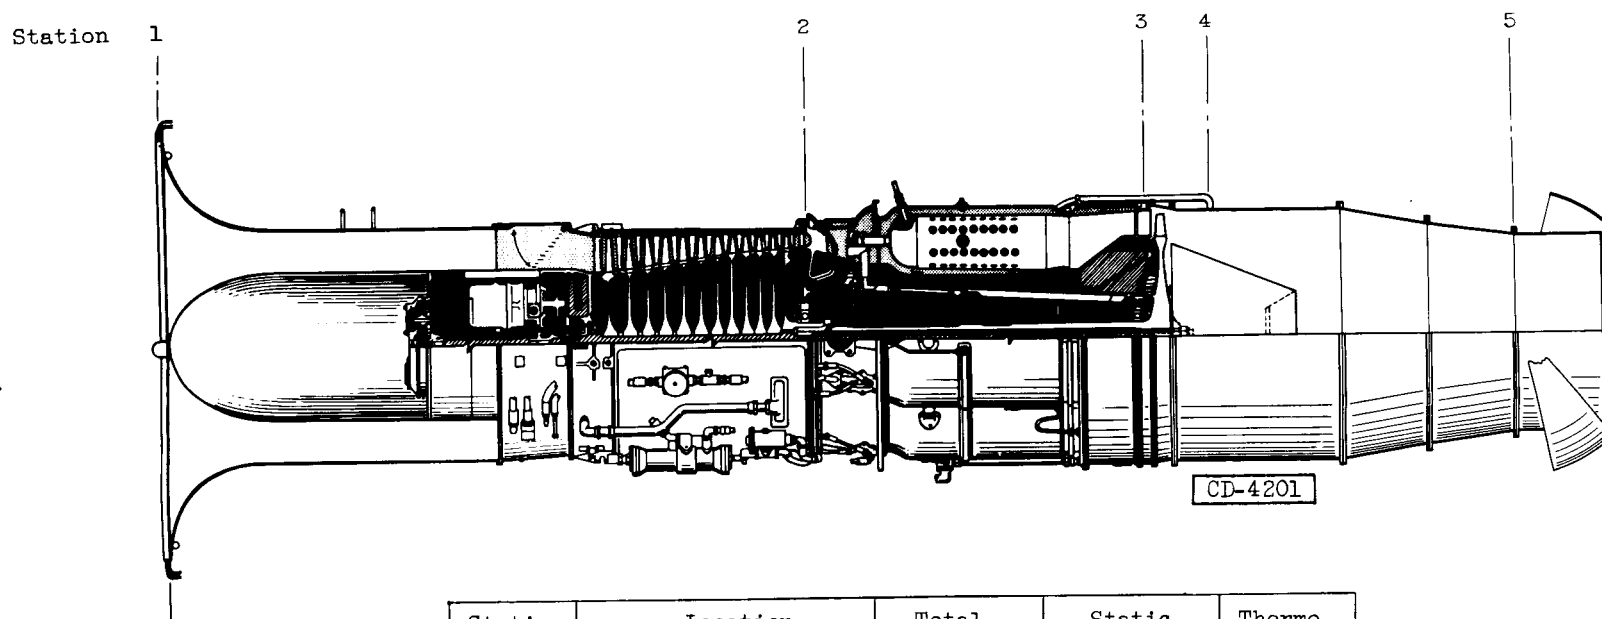
Station	Location	Total-pressure probes	Static-pressure probes	Thermocouples
0	Inlet air measuring station	9	7	4
1	Engine inlet	-	-	20
2	Compressor outlet	10	4	10
3	Turbine inlet	12	-	30
4	Turbine outlet	7	-	20
5	Exhaust-nozzle inlet	12	-	14

Figure 1. - Schematic diagram of turbojet engine showing location of pressure and temperature instrumentation used throughout engine.

Engine and installation. - The turbojet engine used in this investigation was a standard production model with a nominal thrust rating of 5920 pounds at a rotational speed of 7950 rpm and a turbine-discharge gas temperature of 1275° F. A schematic diagram of the engine is shown in figure 1. The following modifications were made to the engine for operation with the trimethyl borate fuel:

Instrumentation. - The number and location of the total- and static-pressure and temperature instrumentation used in this investigation are tabulated in figure 1. Pressure instrumentation used downstream of the combustor outlet was of the air-purging type to exclude collection of boric oxide and subsequent blockage. A sketch of a typical purging-type pressure probe is shown in figure 3.

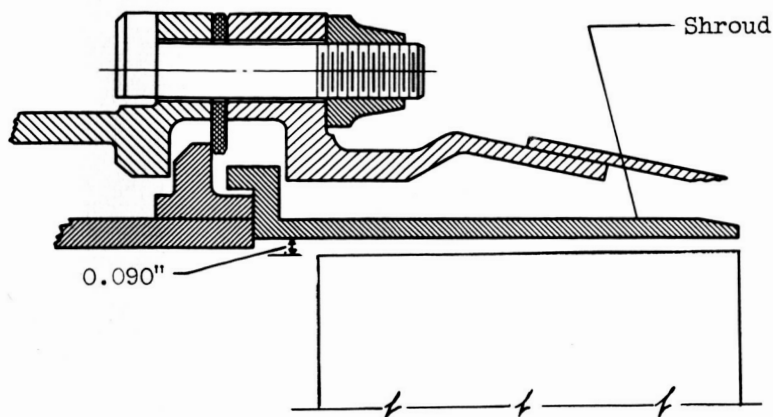
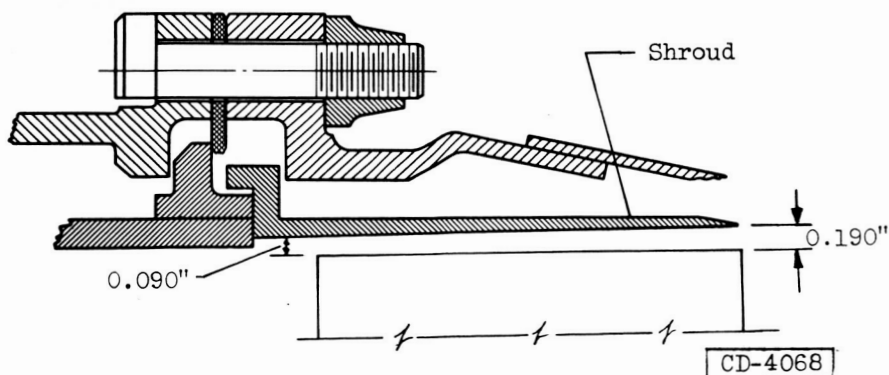
(a) Turbine-clearance increase.

Standard turbine shroud

Modified turbine shroud

Figure 2. - Modifications to standard turbojet-engine components for operation with trimethyl borate fuel.

Configuration	Modifications to standard engine		
	Turbine clearance	Combustor retainer-ring flow area	Fuel nozzles
A	Increased ^a	Increased ^b $3\frac{1}{2}$ times standard area	Large slot enlarged
B	Increased ^a	Blocked	Large slot enlarged
C	Standard	Blocked	Large slot enlarged

^aSee fig. 2(a).

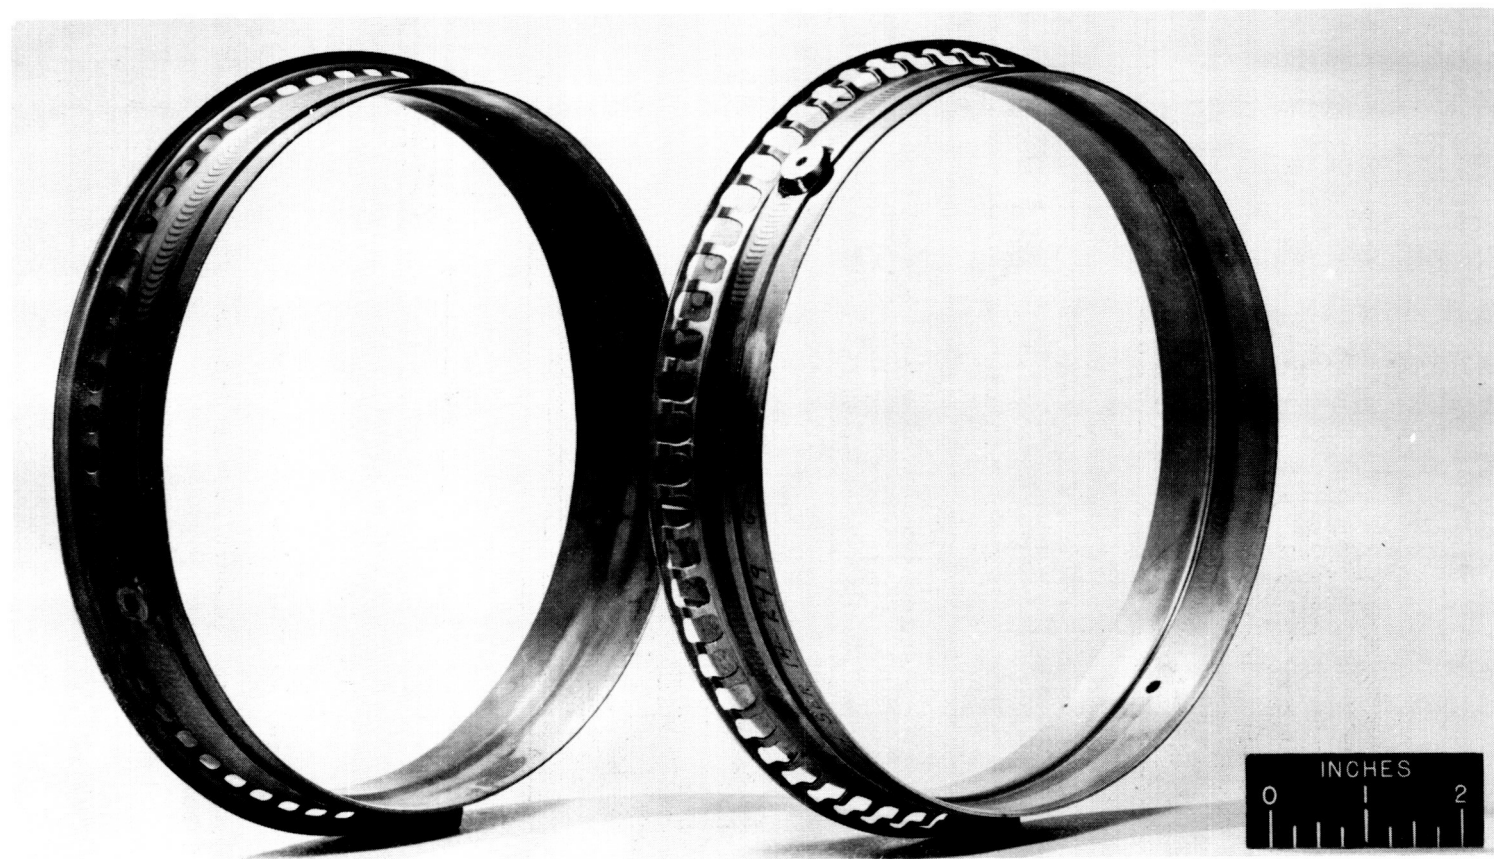
(b) Combustor-outlet retainer-ring modification.

Original

Modified

Figure 2. - Concluded. Modifications to standard turbojet-engine components for operation with trimethyl borate fuel.

^bSee fig. 2(b).

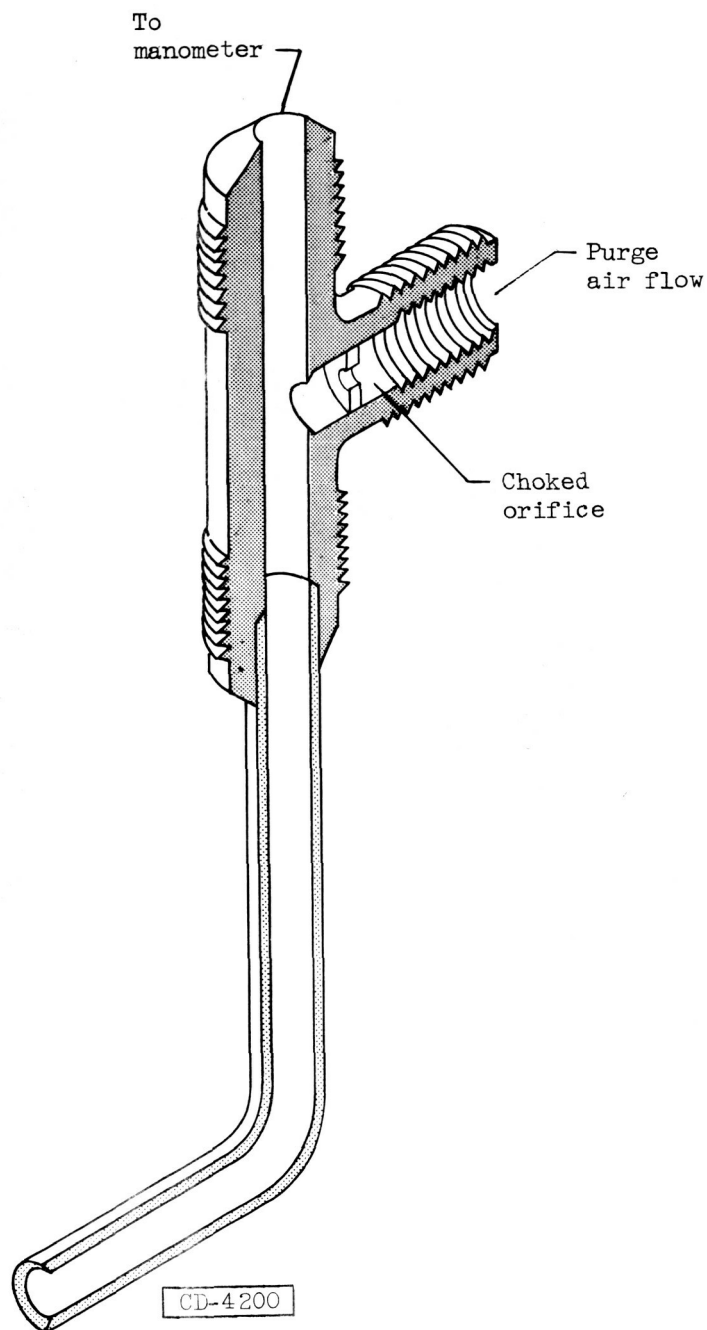
Figure 3. - Purge-type pressure instrumentation used downstream of combustor to prevent boric oxide interference.

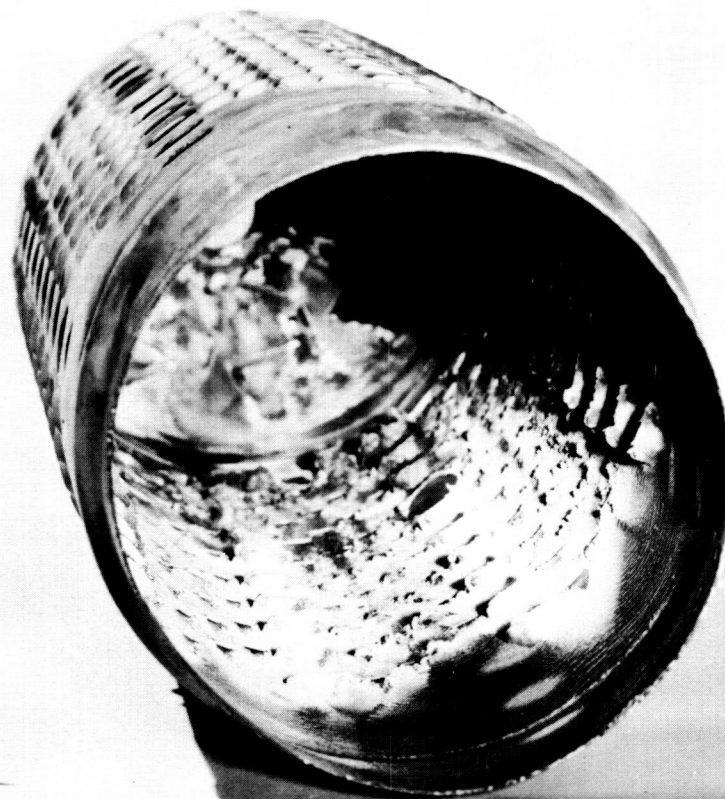
Figure 4. - Boric oxide deposits in combustion chamber following engine start and 7 minutes operation. Configuration A.

Boric oxide deposition. - The engine was successfully started with trimethyl borate fuel, and only moderate immediate deposits were formed on the relatively cold metal components during starting. The deposits

in a typical combustion chamber are shown in figure 4 following the engine start and approximately 7 minutes of operation.

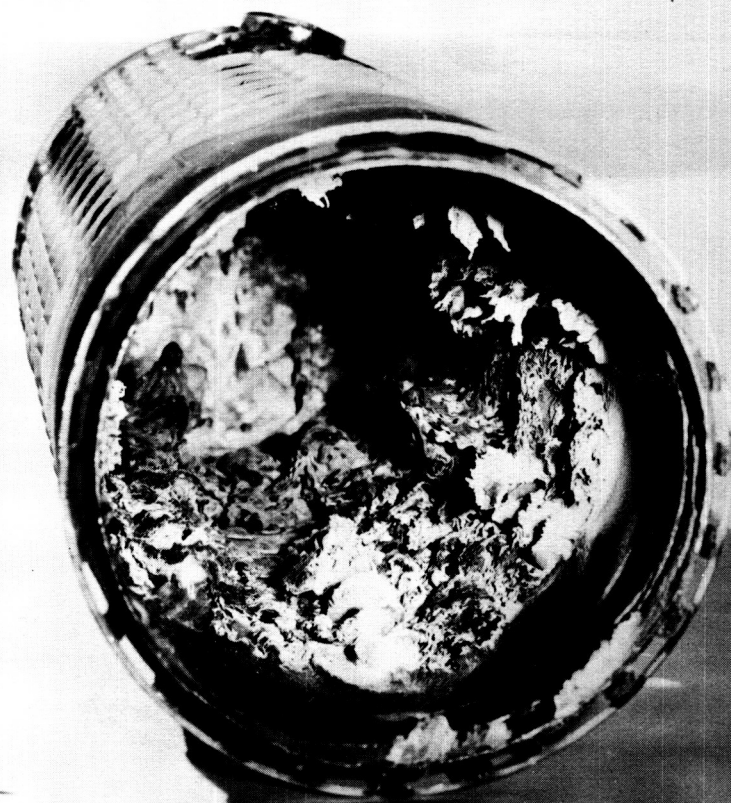
(a) Combustion chamber with thimble liner.

Figure 5. - Boric oxide deposits in turbojet-engine components following 2 hours operation with trimethyl borate fuel. Rated engine conditions. Sea-level static operation. Configuration A.

After 2 hours of operation with trimethyl borate fuel, the boric oxide deposits reached the state shown in figure 5. Figure 5(a) shows the deposits in the combustion-chamber liner that was equipped with thimbles that protruded into the combustion chamber to provide additional turbulence in the combustion zone. The liner of figure 5(b) was without thimbles. Both types of combustor liner are in use in current turbojet engines. In general, these deposits were vitreous with only minor crystalline formations. Figure 5(c) compares a clean liner with the plugging obtained longitudinally in a combustion-chamber liner after 2 hours of operation with trimethyl borate. The oxide deposits in the tail pipe following the same period of operation are shown in figure 5(d). Although some crystalline deposits are visible, the majority of the oxide in the tail pipe is in a vitreous form and appears to have been plastic while still molten.

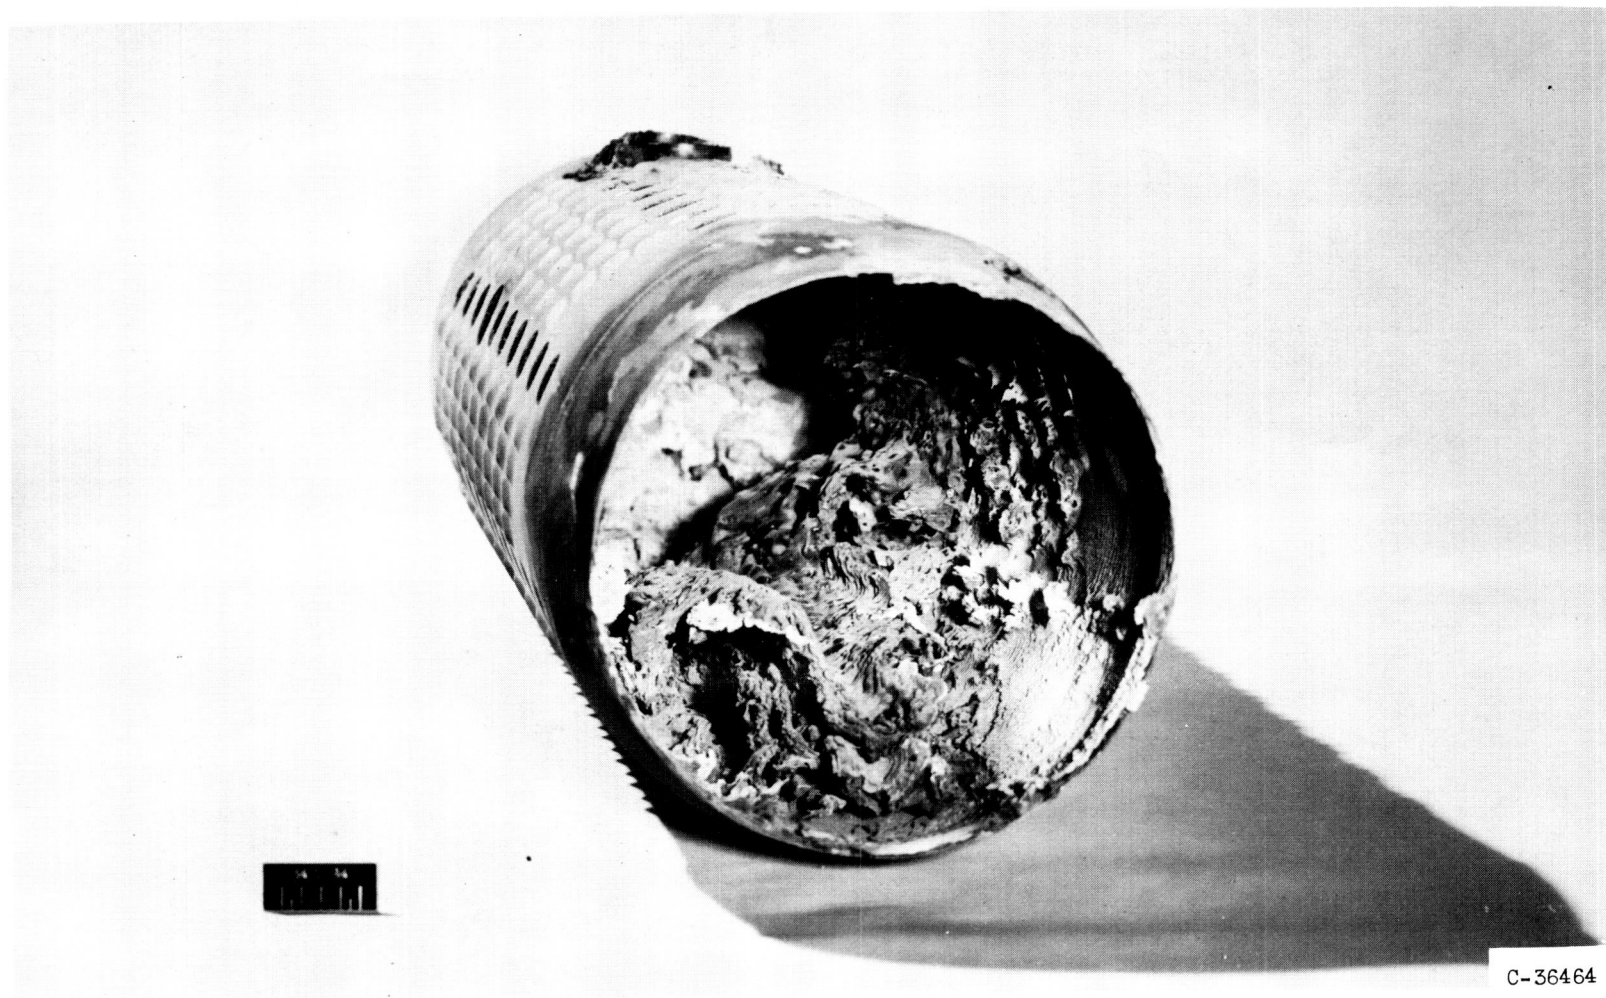
(b) Combustion chamber with thimbleless liner.

Figure 5. - Continued. Boric oxide deposits in turbojet-engine components following 2 hours operation with trimethyl borate fuel. Rated engine conditions. Sea-level static operation. Configuration A.

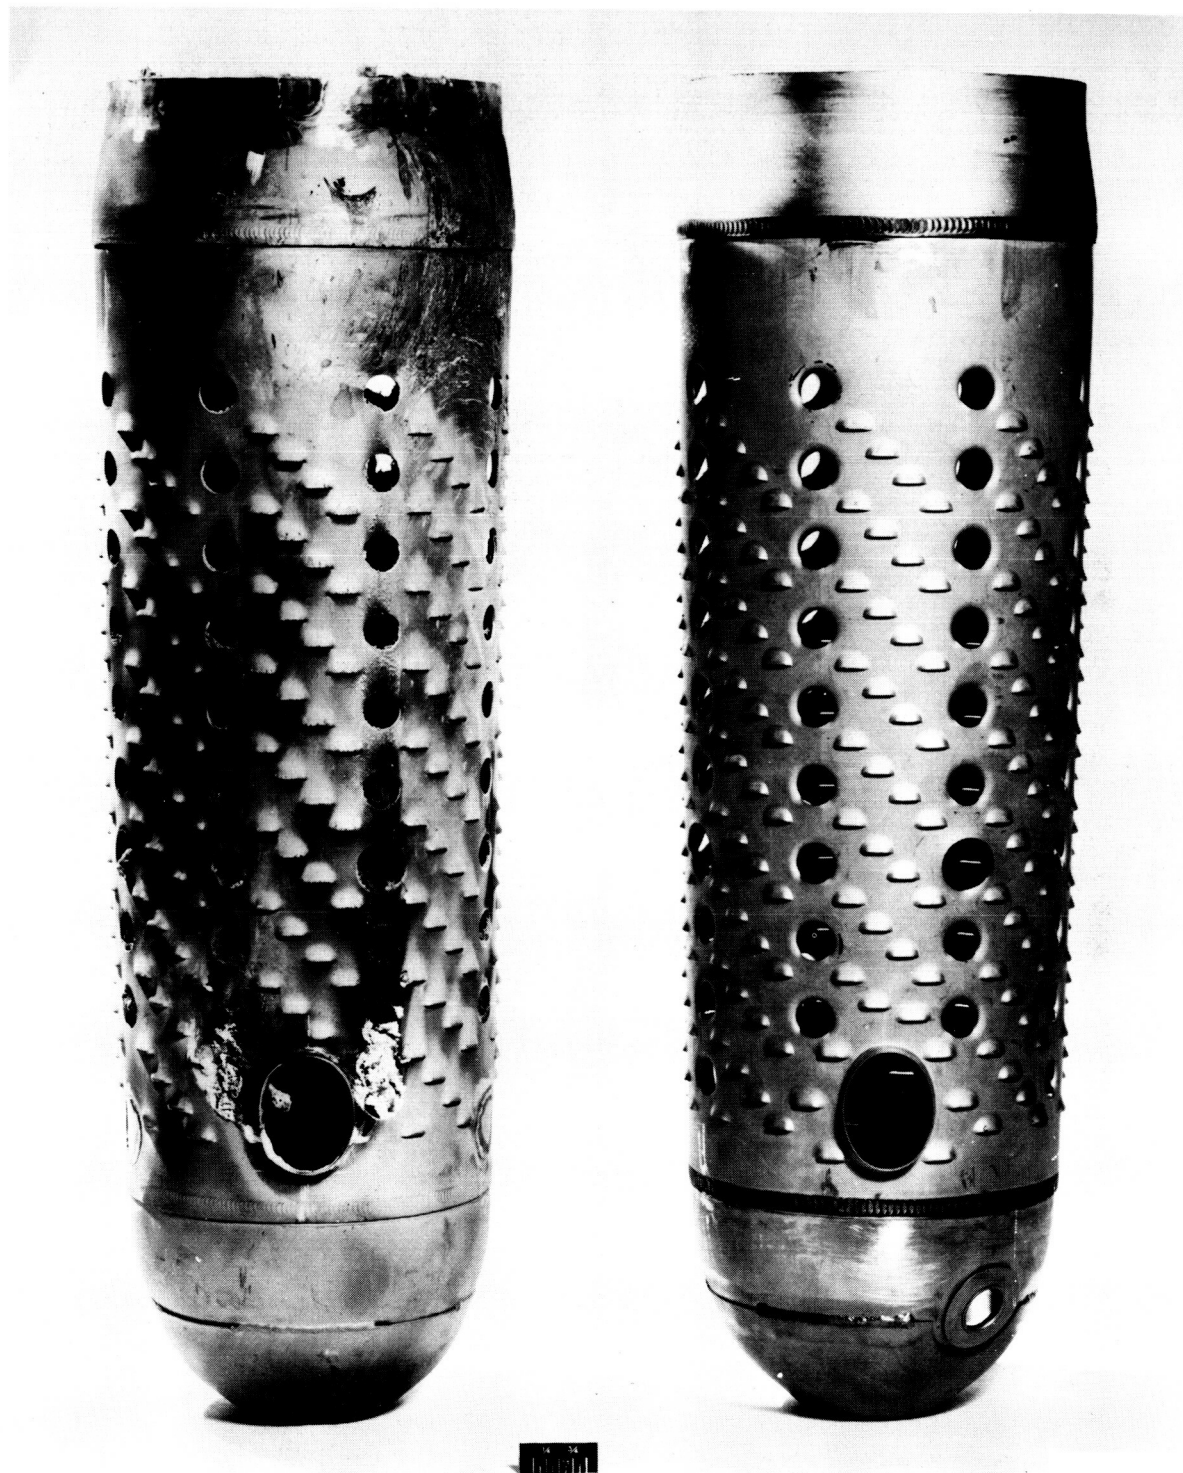
(c) Longitudinal boric oxide deposition compared with clean combustion-chamber liner.

Figure 5. - Continued. Boric oxide deposits in turbojet-engine components following 2 hours operation with trimethyl borate fuel. Rated engine conditions. Sea-level static operation. Configuration A.

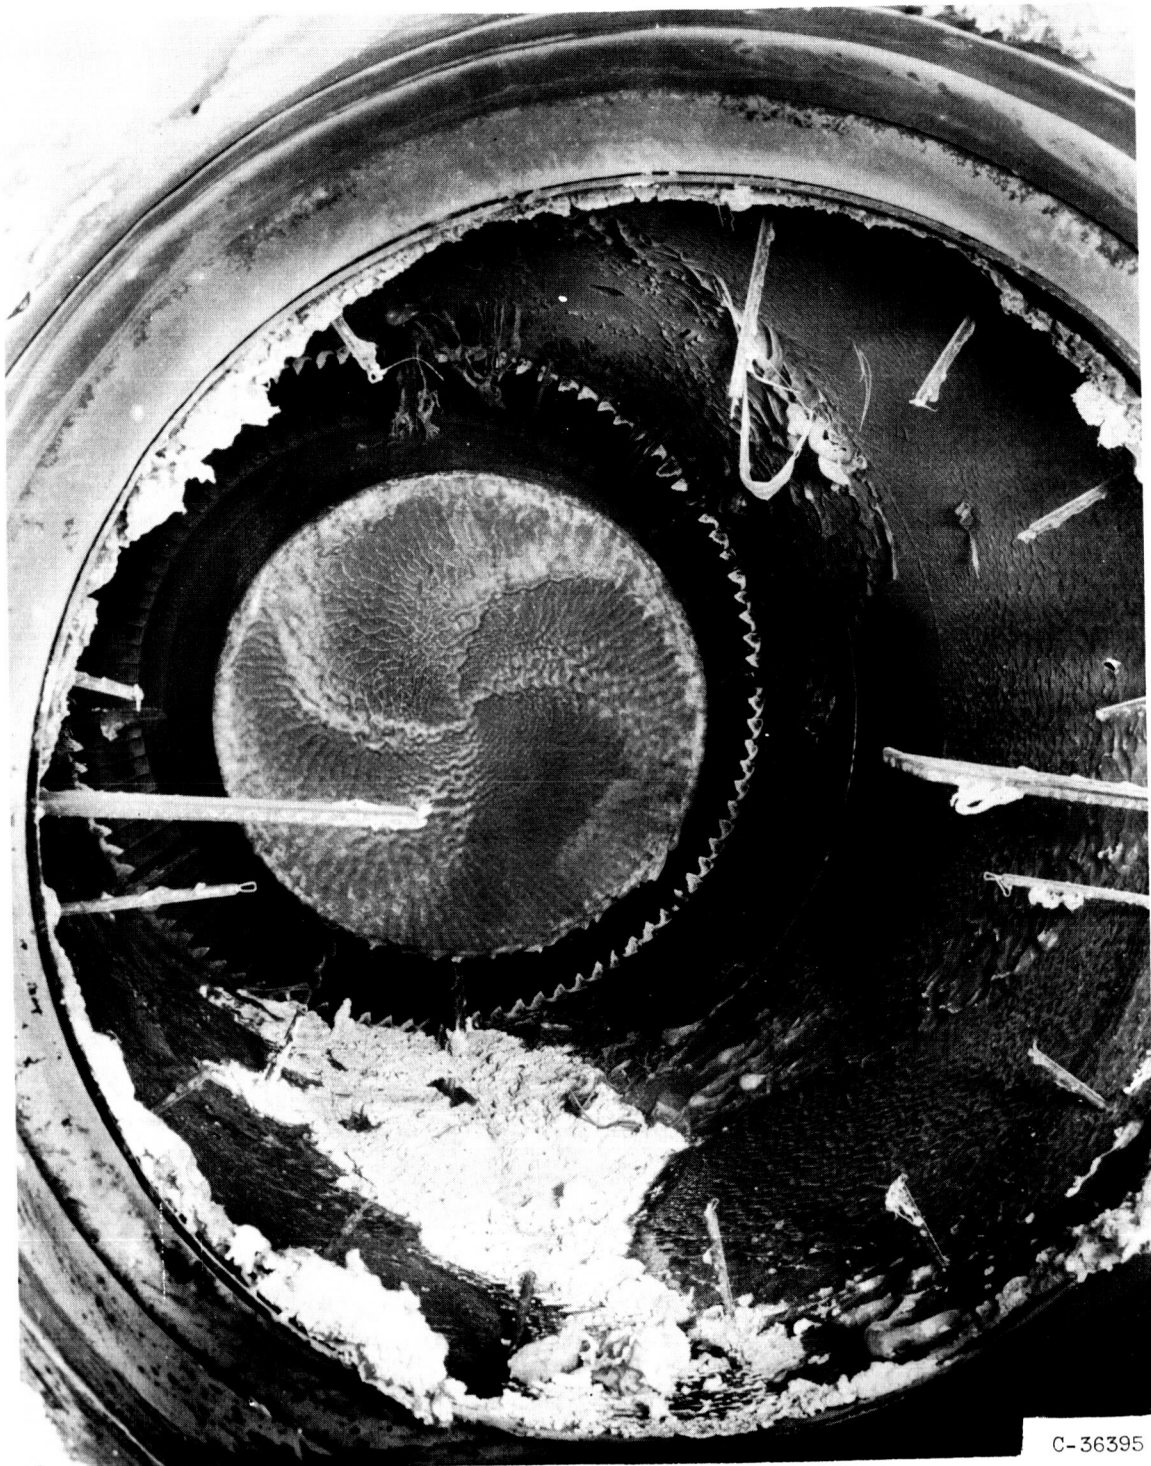
(d) Engine tail pipe, looking upstream.

Figure 5. - Concluded. Boric oxide deposits in turbojet-engine components following 2 hours operation with trimethyl borate fuel. Rated engine conditions. Sea-level static operation. Configuration A.

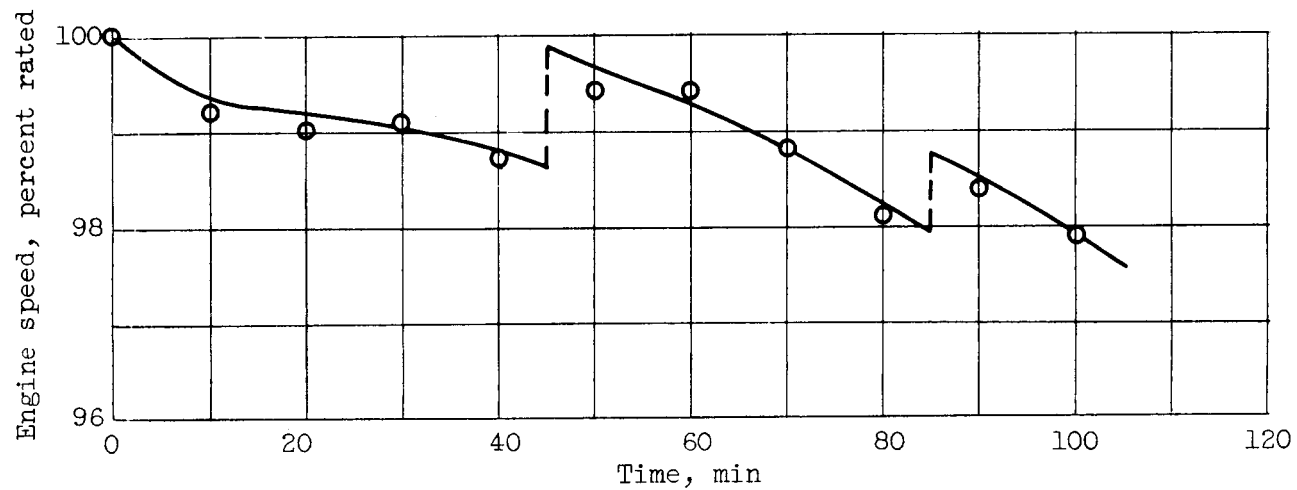
Figure 6. - Effect of boric oxide deposition on turbojet-engine speed.
Configuration A. Tail-pipe temperature, 1700° R.

Engine operation and performance. - The engine fuel flow and exhaust-nozzle area were maintained constant and the engine speed was permitted to decrease so as to maintain a tail-pipe temperature of 1700° R. A maximum engine speed decrease of 2 percent was measured using configuration A as is shown in figure 6. The decrease in engine speed resulted from the increased combustor pressure drop and the burning of some of the fuel downstream of the turbine as may be seen from figure 7. Operation was for 100 minutes with trimethyl borate fuel. The irregular changes in engine speed that occurred at 45 and 85 minutes are believed to have resulted from the dislodgment of sizeable quantities of the accumulated deposits of the combustor.

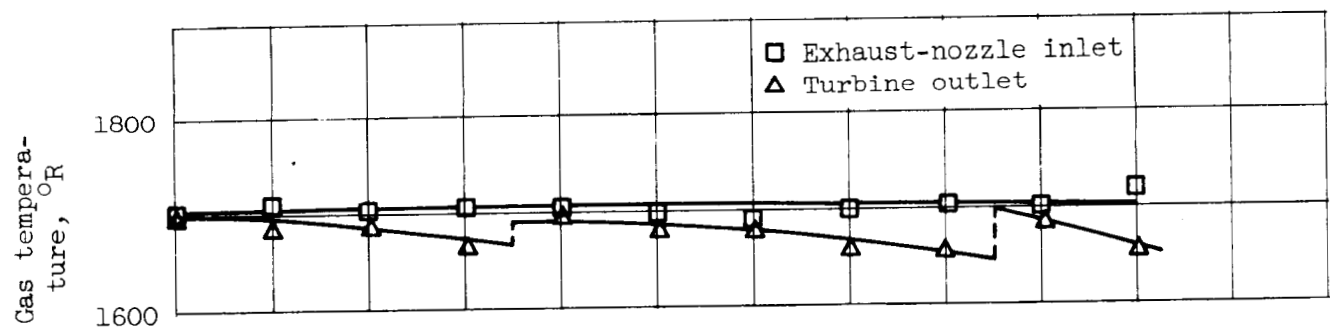
(a) Turbine-outlet and exhaust-gas temperatures.

Figure 7. - Effect of boric oxide deposition on turbojet-engine temperatures and pressures. Configuration A. Tail-pipe temperature, 1700° R.

It may be seen in figure 7(a) that the turbine-discharge gas temperature decreased with time (increasing deposition) while the gas temperature measured downstream (at the exhaust-nozzle inlet) remained constant.

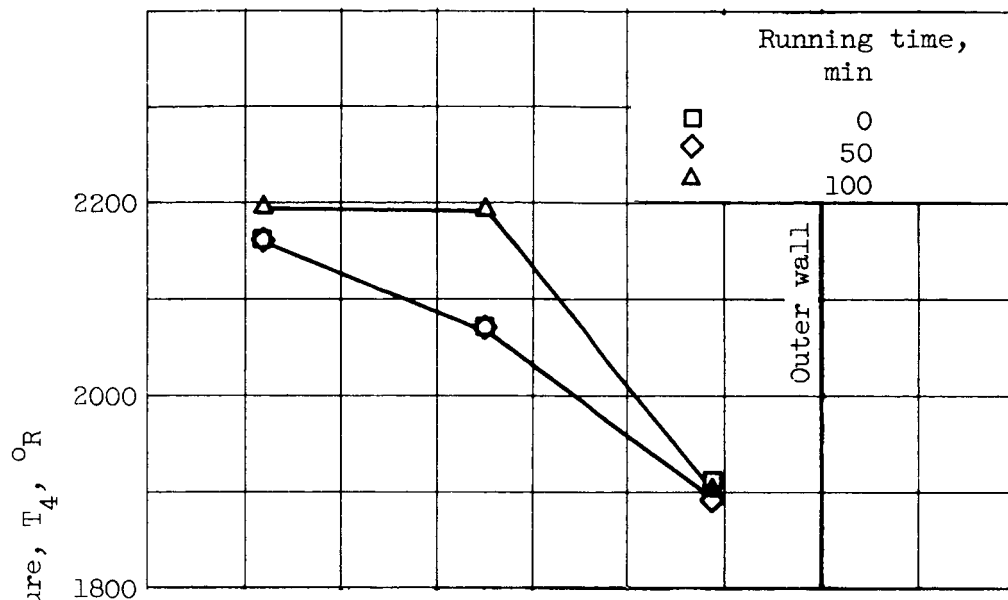
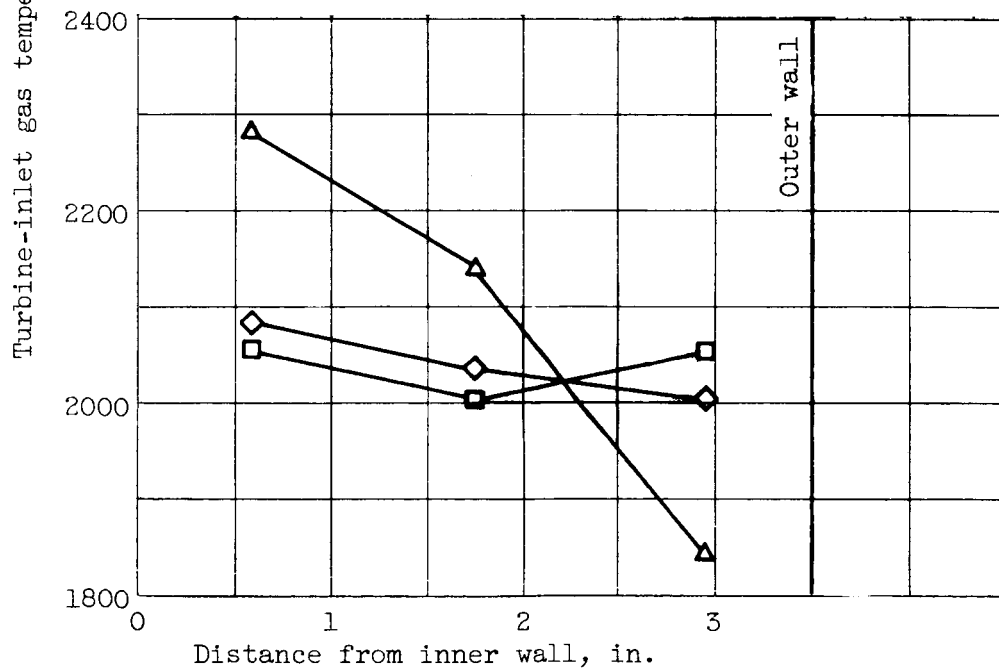
(a) Downstream of combustor 1.

(b) Between combustors 1 and 2.

Figure 8. - Change in turbine-inlet gas-temperature profiles with operation of engine with trimethyl borate fuel.

at the turbine. Figure 8 shows the variation of the turbine-inlet gas-temperature profile at several time intervals during operation with trimethyl borate. Radial profiles are shown for positions at the turbine inlet both behind a combustor and between two combustors. In general, a somewhat steeper temperature gradient from the inner portion of the annulus to the outer wall was experienced with prolonged use of the trimethyl borate. The change in turbine-inlet total-pressure profile is shown in figure 9. Both the circumferential pressure distribution (fig. 9(a)) and the radial pressure profile (fig. 9(b)) were slightly altered because of the accumulated boric oxide deposits in the combustor.

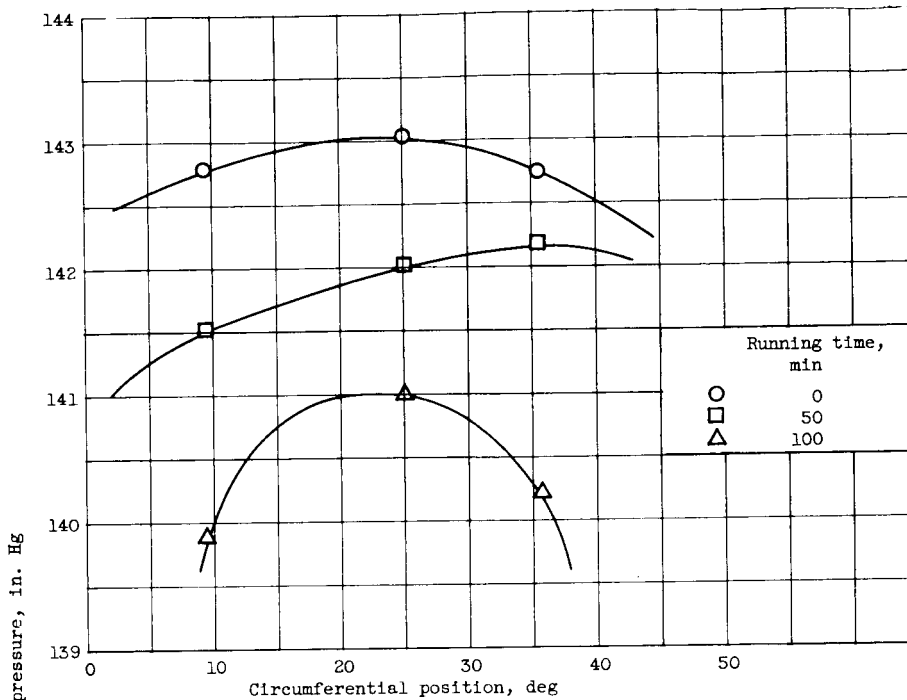
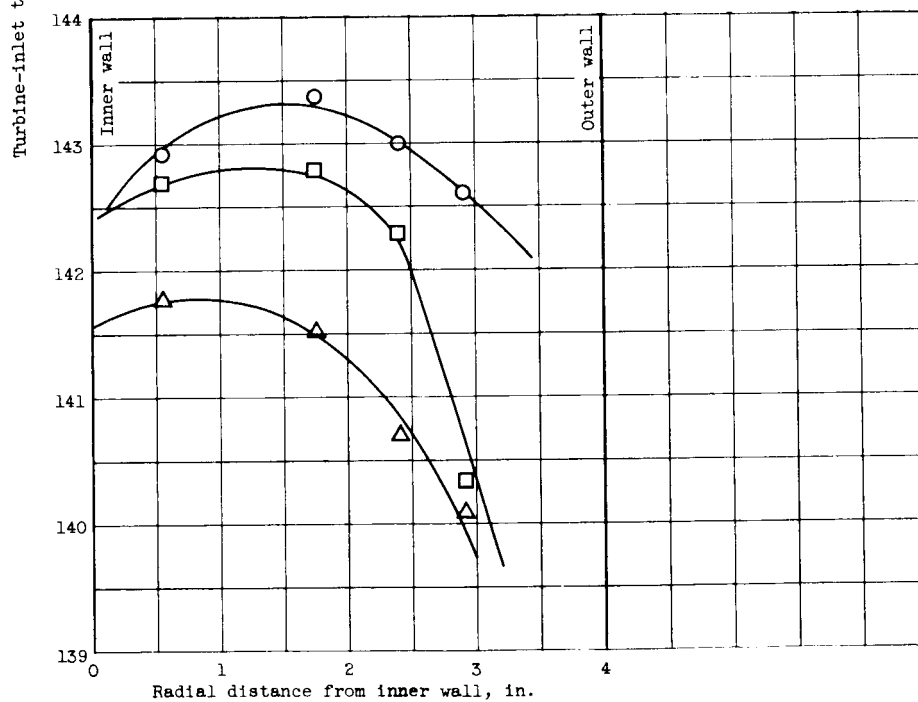
(a) Circumferential pressure distribution.

(b) Radial pressure profile.

Figure 9. - Change in turbine-inlet total-pressure profiles with operation of engine with trimethyl borate fuel.

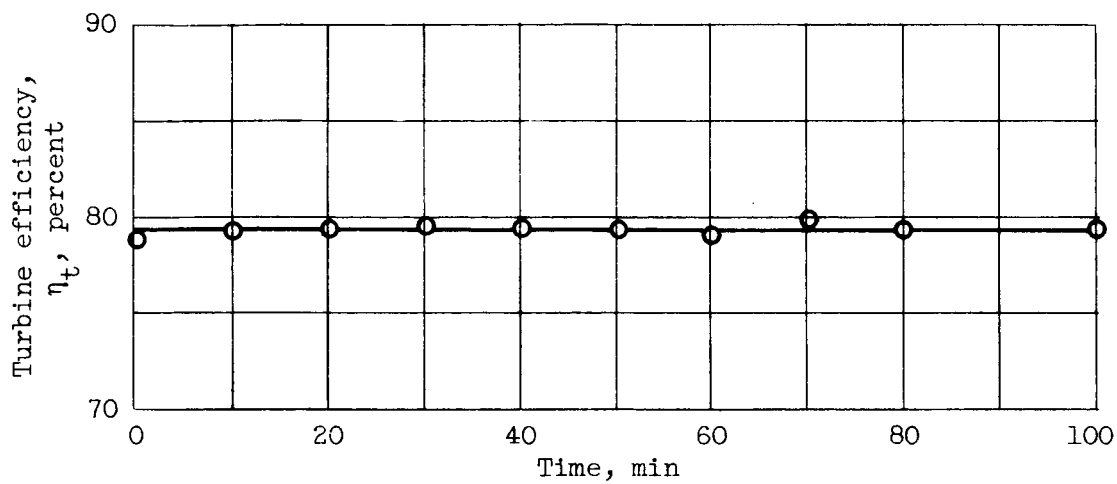
Figure 10. - Effect of operation of turbojet engine with trimethyl borate fuel on turbine efficiency. Tail-pipe temperature, 1700° R.

Although the combustor deposits altered the temperature and pressure distributions entering the turbine nozzle diaphragm, these relatively small changes were insufficient to produce a measurable change in the performance of the turbine. The turbine efficiency (fig. 10) remained constant throughout the investigation even with prolonged use of the trimethyl borate fuel.

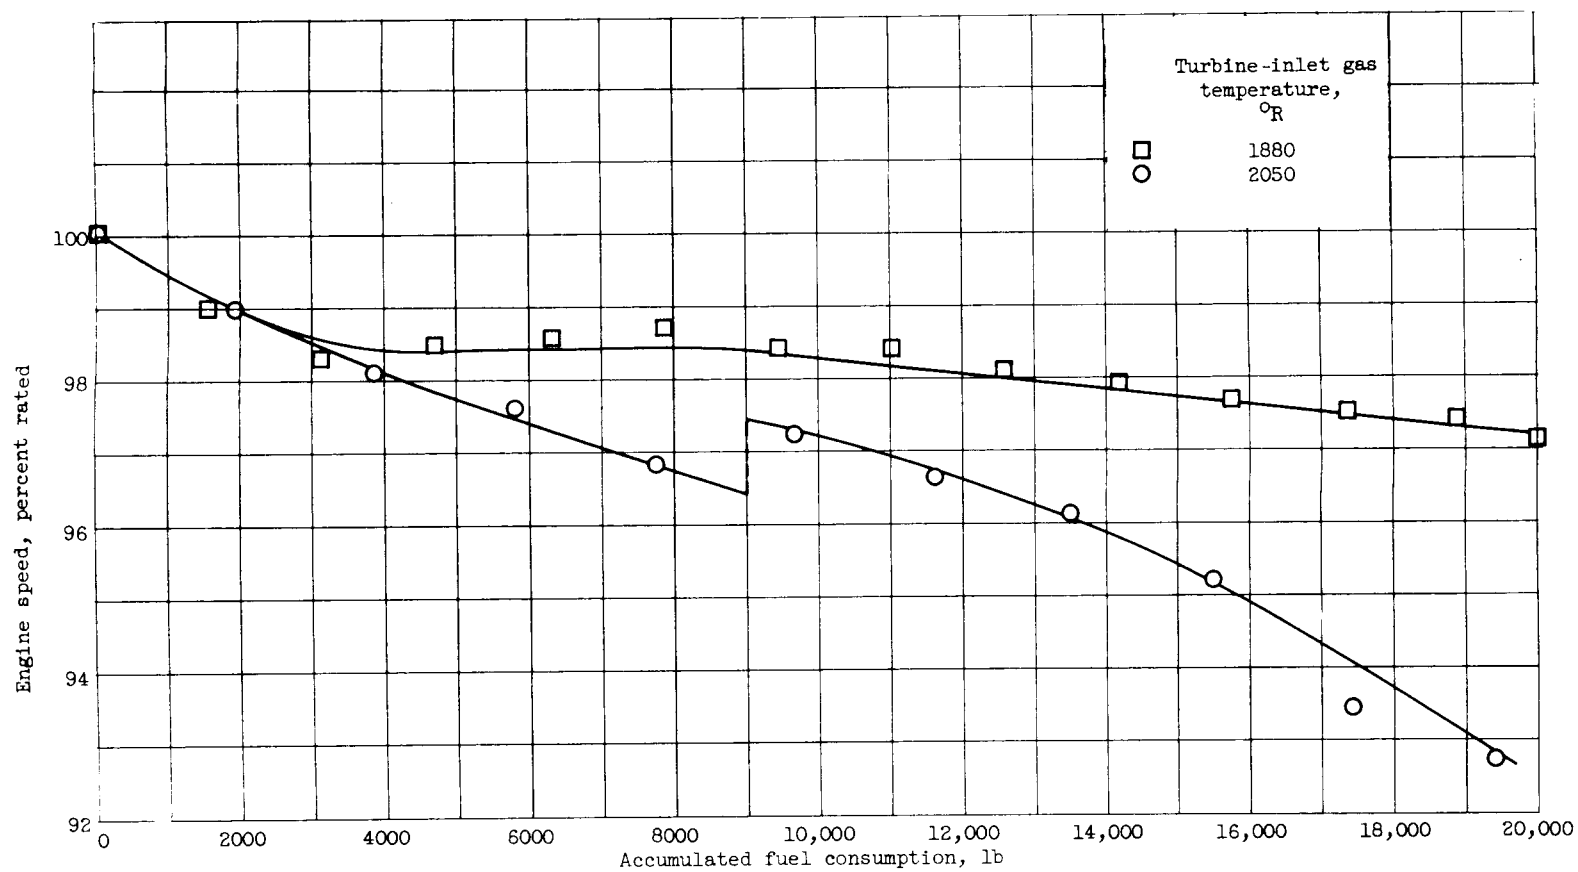
Figure 11. - Effect of turbine-inlet temperature on engine speed deterioration during operation with trimethyl borate fuel. Configuration B.

With a turbine-inlet gas temperature of 1880° R, the oxide deposits caused a 2.8-percent reduction in engine speed. Increasing the turbine-inlet temperature from 1880° to 2050° R caused an engine speed deterioration of approximately 7.3 percent for a similar quantity of fuel consumption. The comparison of engine speed deterioration is presented in figure 11 as a function of the accumulated fuel consumption because the oxide formation is a direct function of the fuel-consumption rate. The tendency to increase the oxide deposition and consequently cause a further speed deterioration with increased turbine-inlet temperature is contrary to expectation. It was anticipated that the erosion would increase with the reduced viscosity of the deposits at higher temperatures. The increased oxide-deposition trend, however, has been substantiated with unpublished data obtained on a single combustor rig. It is believed that this incongruity can be explained by the fact that the

The irregularity of the data shown in figure 11 for 2050° R turbine-inlet temperature for fuel consumption between 8000 and 10,000 pounds is again believed due to a sudden change in the deposits such as would occur with the dislodgment of large pieces.

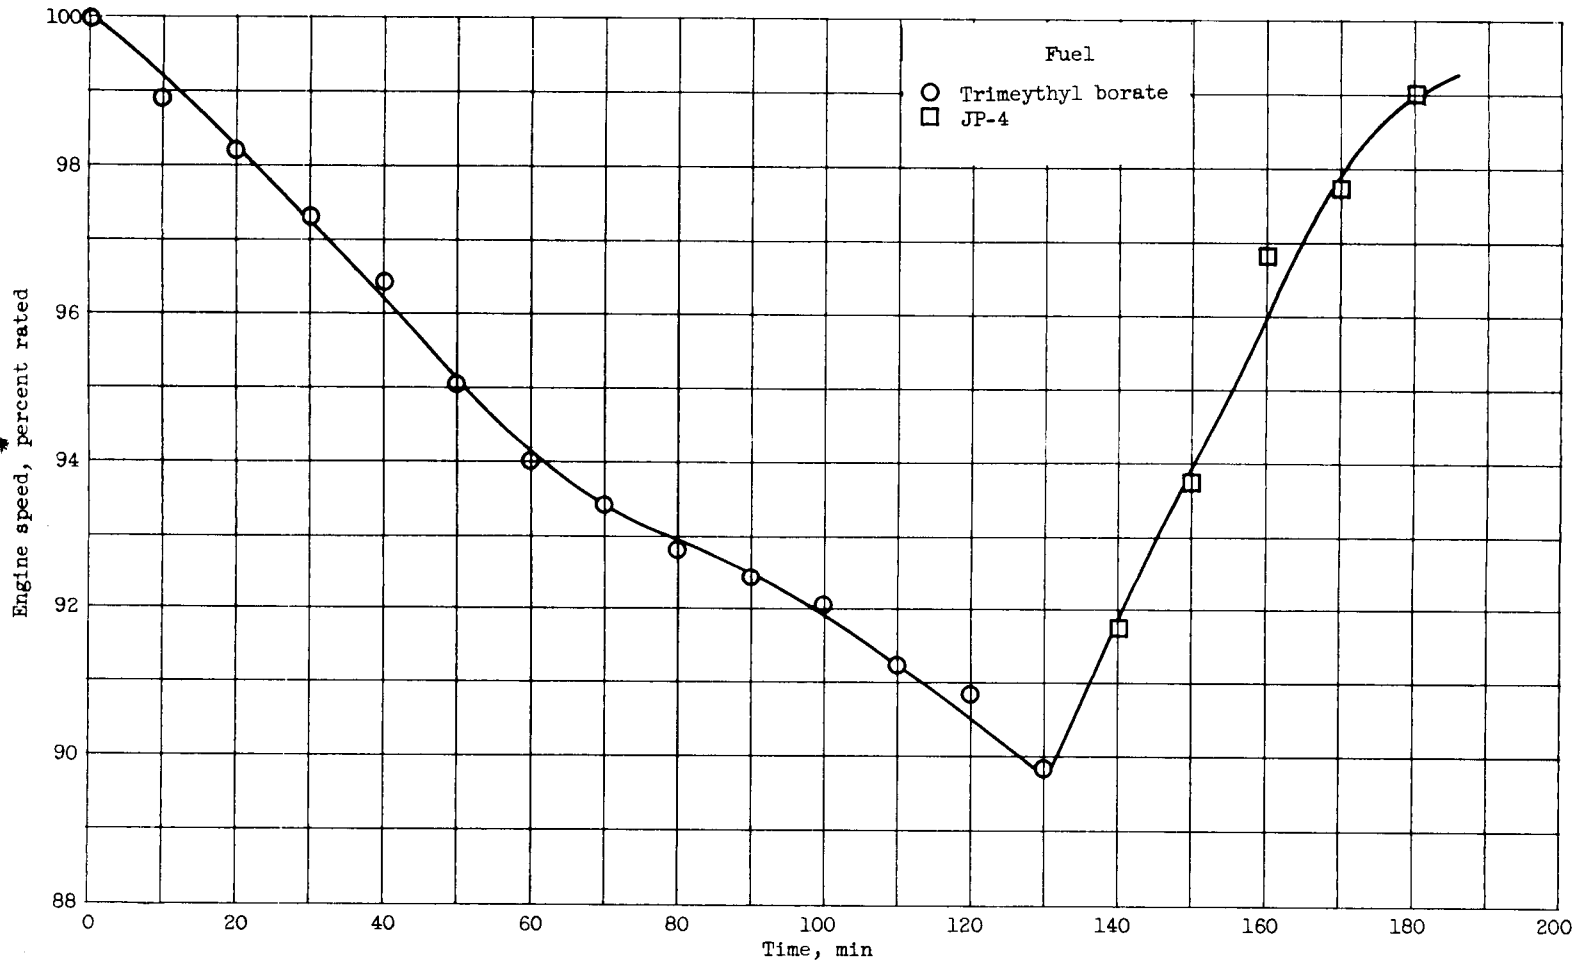
Figure 12. - Dissipation of effect of boric oxide deposits in engine components by operation with JP-4 fuel. Rated engine conditions. Static sea-level operation. Tail-pipe temperature, 1700° R. Configuration C.

Subsequent to the operation with trimethyl borate, the engine was operated with hydrocarbon fuel, JP-4. After about 50 minutes of operation with JP-4, the engine speed approached normal operation, as is shown in figure 12, indicating substantial removal of the deposits. Visual inspection showed that the deposits throughout the engine were dissipated by the JP-4 operation. Figure 13(a) shows the deposits in a typical combustor following operation with JP-4 fuel, and figure 13(b) shows the relatively minor deposits remaining in the engine tail pipe.

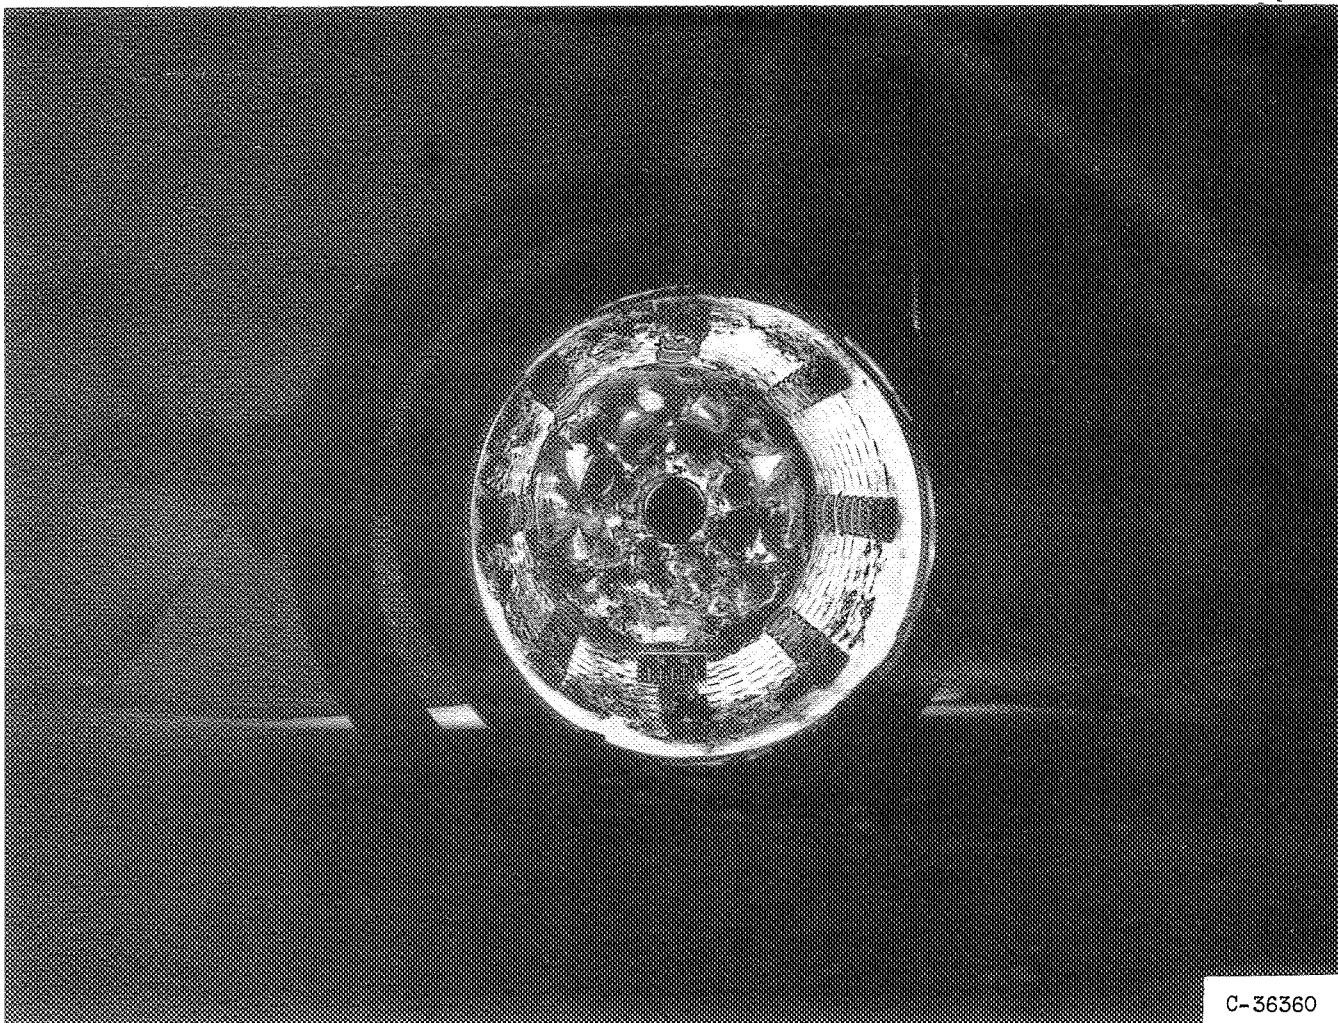
(a) Combustion chamber.

Figure 13. - Boric oxide deposits in engine components following operation with JP-4 fuel for 50 minutes. Previous trimethyl borate operation for 130 minutes. Configuration C.

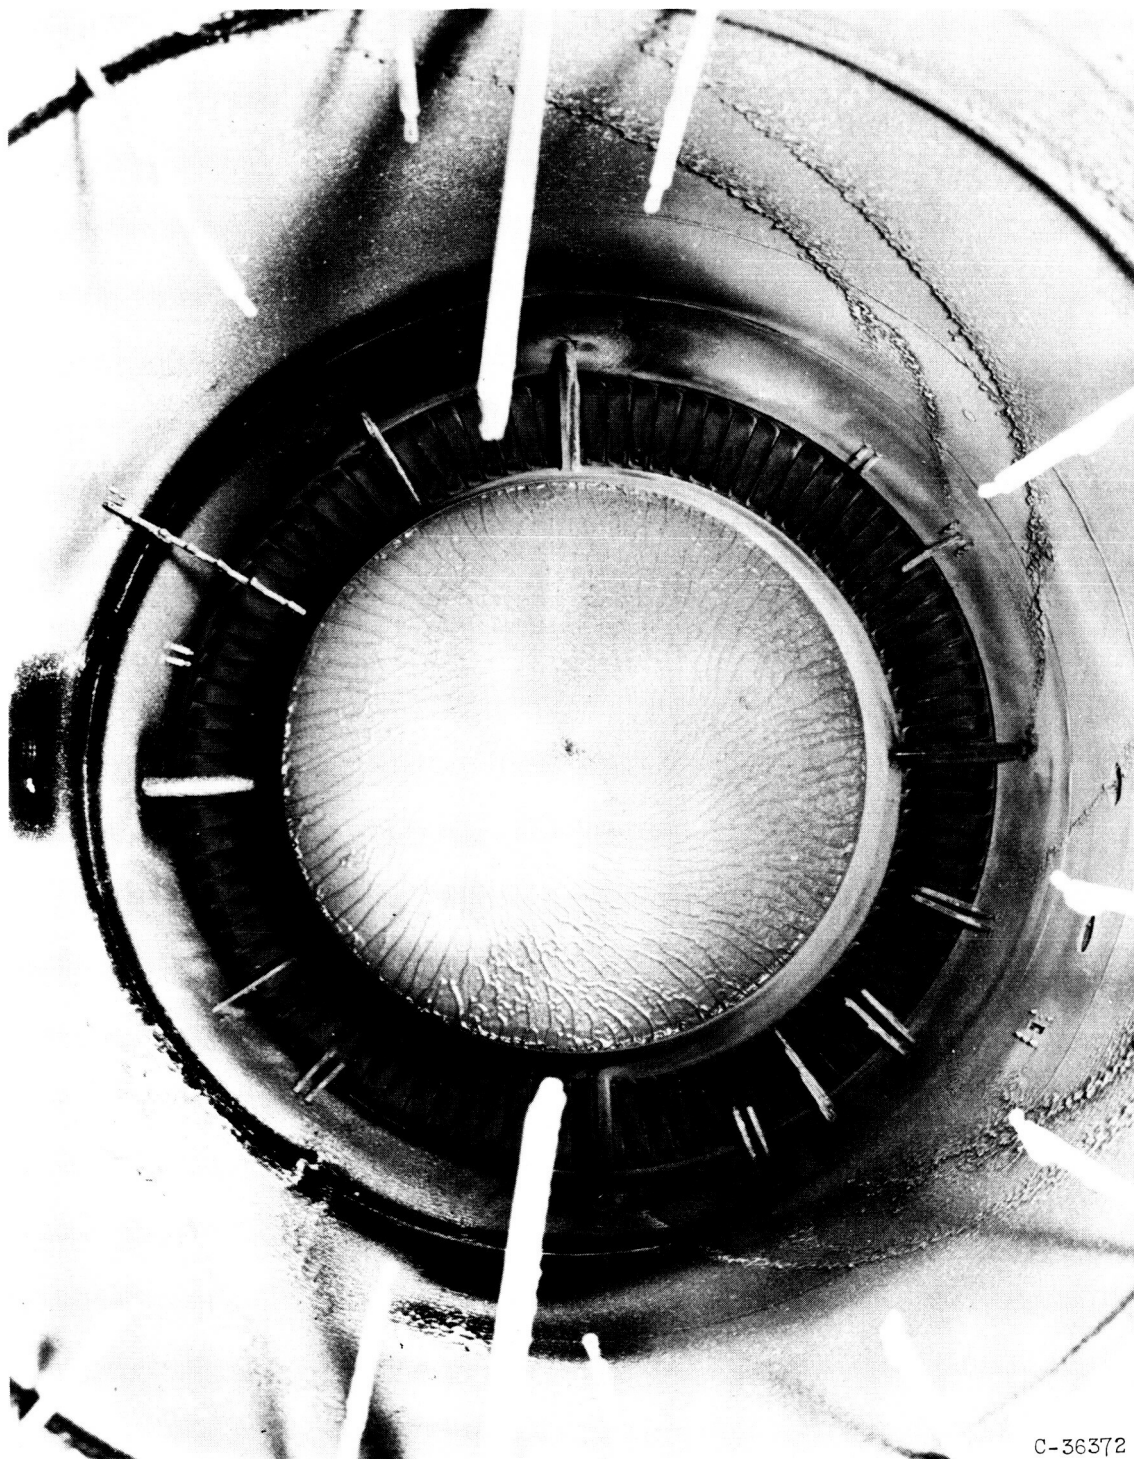
(b) Engine tail pipe, looking upstream.

Figure 13. - Concluded. Boric oxide deposits in engine components following operation with JP-4 fuel for 50 minutes. Previous trimethyl borate operation for 130 minutes. Configuration C.
